# Manhole Inspection Summary

Manhole # S35MM\_026MH

Insp Date: **4/5/07 1:18 PM**

**Location** Address: **101 21ST ST**

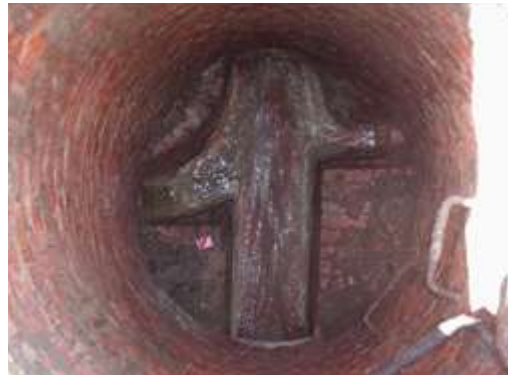
Top View

☒ **Debris** (not Condition related)

☒ **Corroded**

☒ **Evidence Of Surcharge**

Depth: **1.5** (ft.)

Corroded steps. Evidence of surcharge - Bench debris.

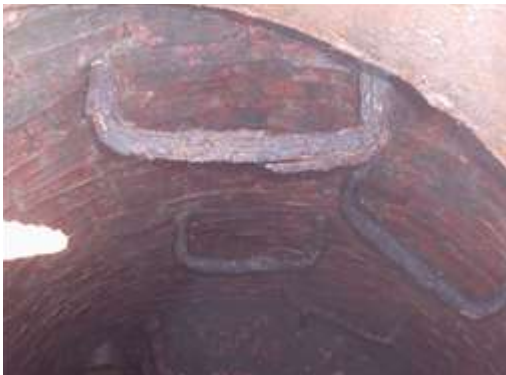
Defect

☒ **Deteriorated**

☒ **Joint**

☒ **Wall**

Corbel deterioration and infiltration.

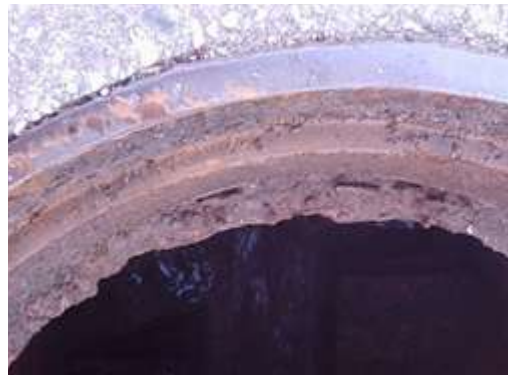
Defect

Offset: **1** (in.)

☒ **Leaks**

Frame leaks.

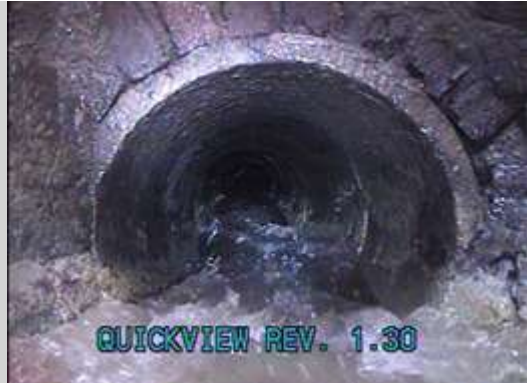
### 18 in. Circular Gravity Sewer Pipe Out @ 12 O'Clock

Infiltration: **None** Pipe Seal Cond: **Cracked**

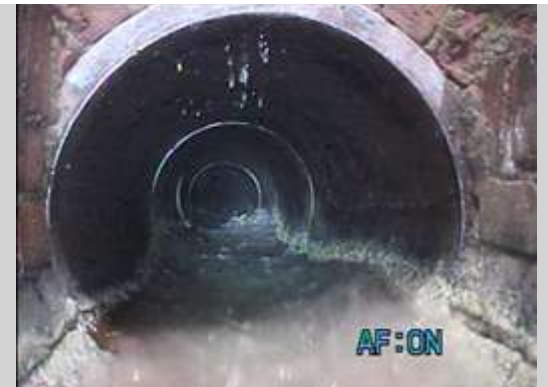
### 15 in. Circular Gravity Sewer

☒ **Deteriorated**

Channel deterioration.

Deposits: ☐ None ☐ Mud ☐ Sludge ☐ Debris ☒ Grease

Silt Depth: **0** (in.) Deposits Extent: **Light**
